**Special Investigation Report - Derailments of
New York City Transit Authority Trains
Involving Traction Motor Mount Failures**

**DERAILMENTS OF NEW YORK CITY
TRANSIT AUTHORITY TRAINS INVOLVING
TRACTION MOTOR MOUNT FAILURES**

NTSB-TSR-SIR-82-2

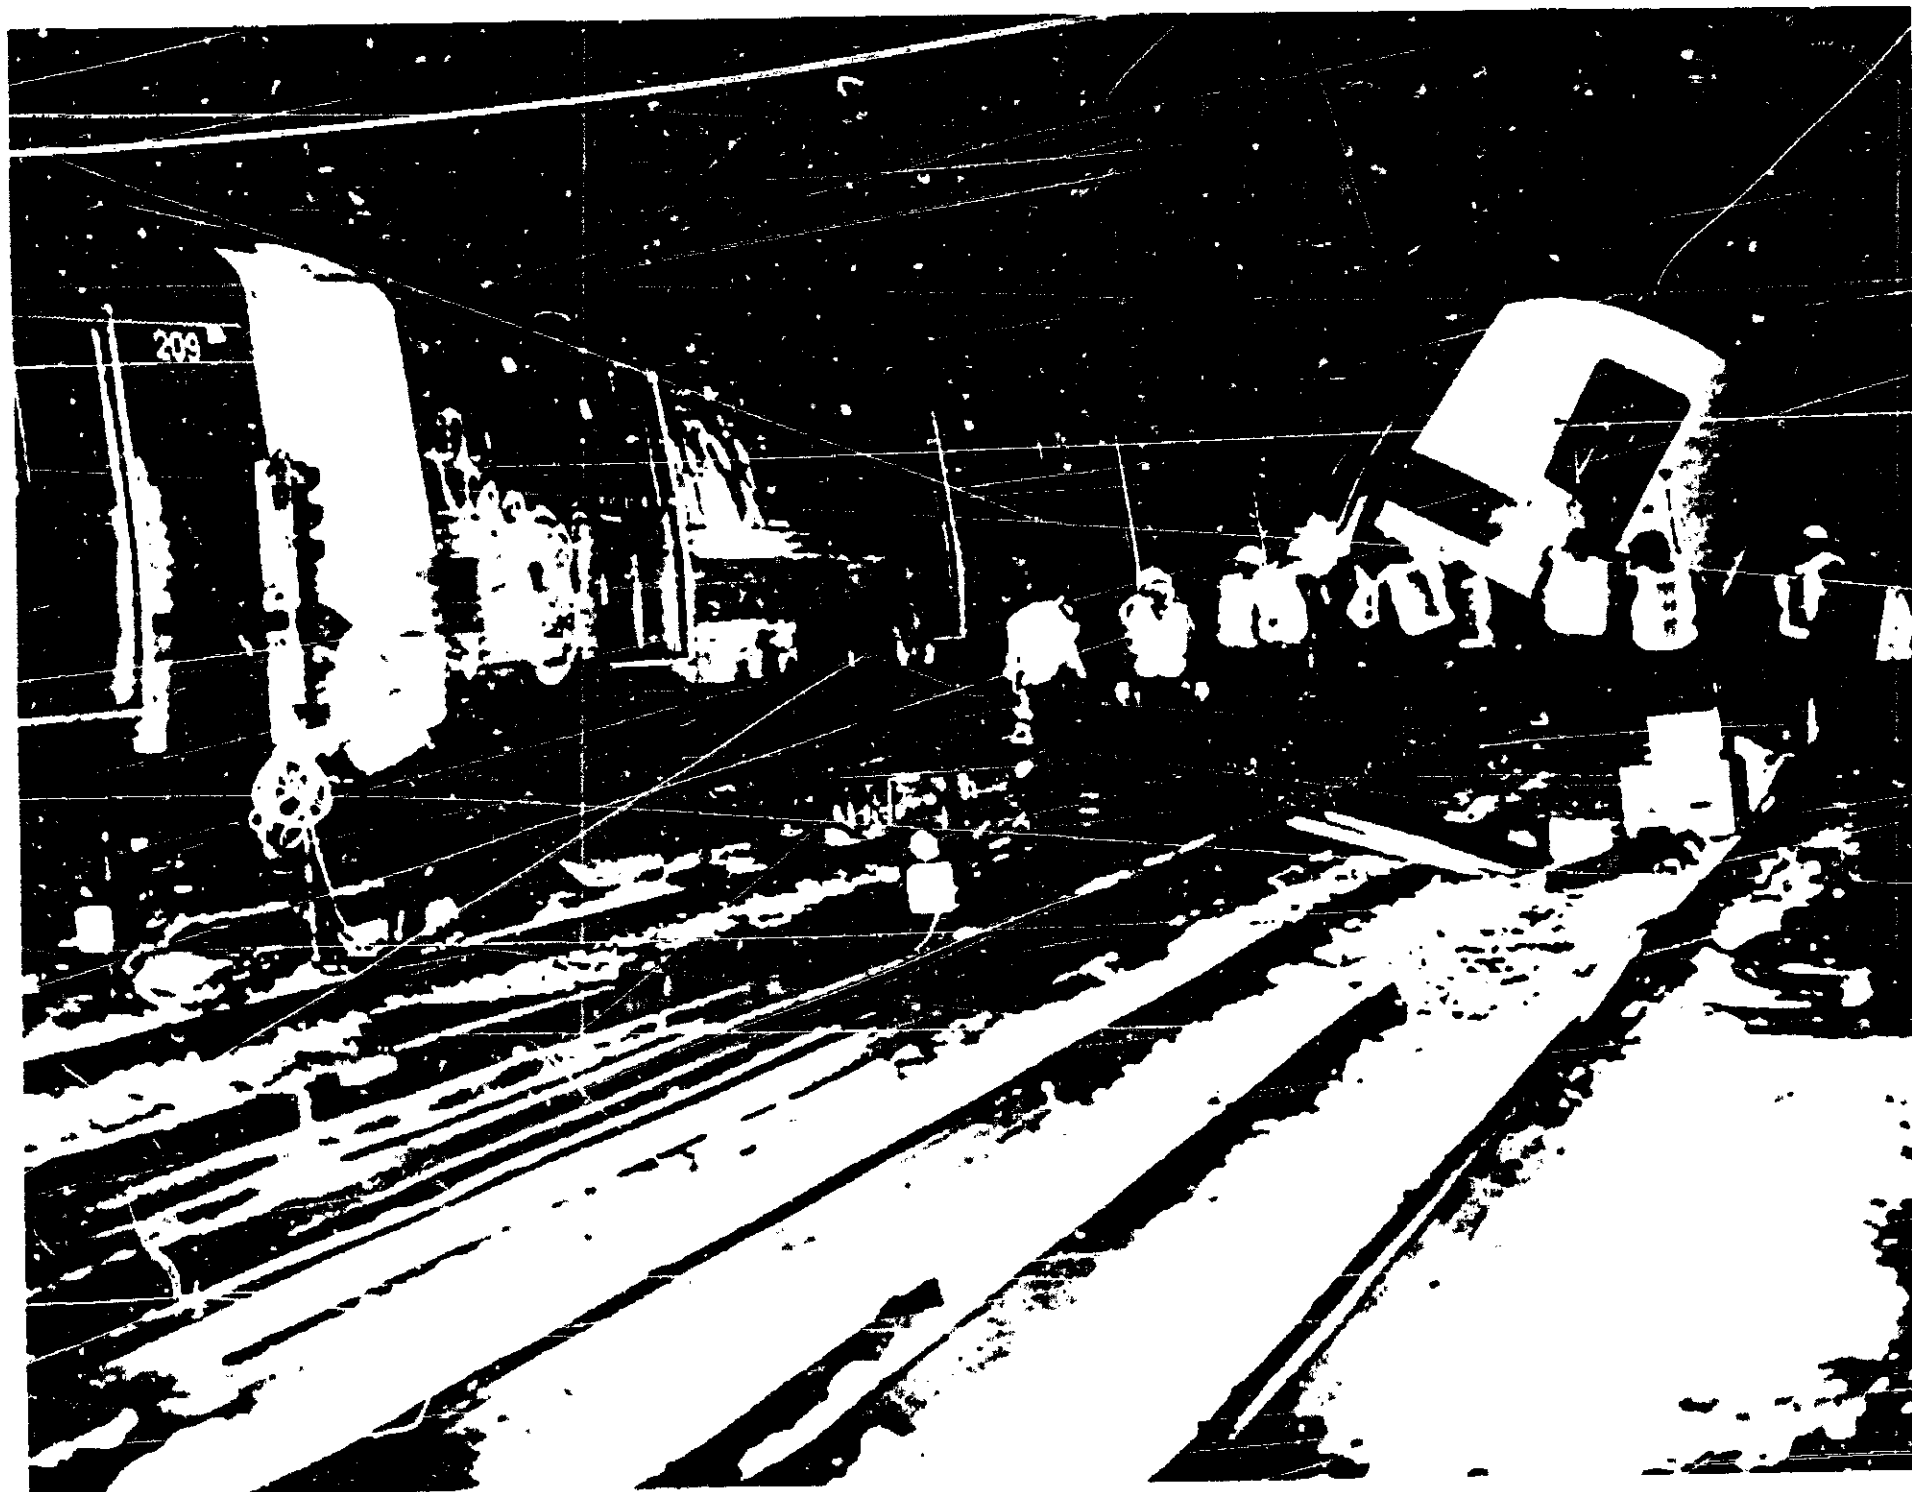
Figure 1.- -Derailment of NYCTA subway train on January 12, 1981.

evacuated along the track to the Kings Highway Station. The fire department departed at 1:13 a.m. after all passengers, including three injured persons, had been evacuated. Damage was estimated to be \$129,000.

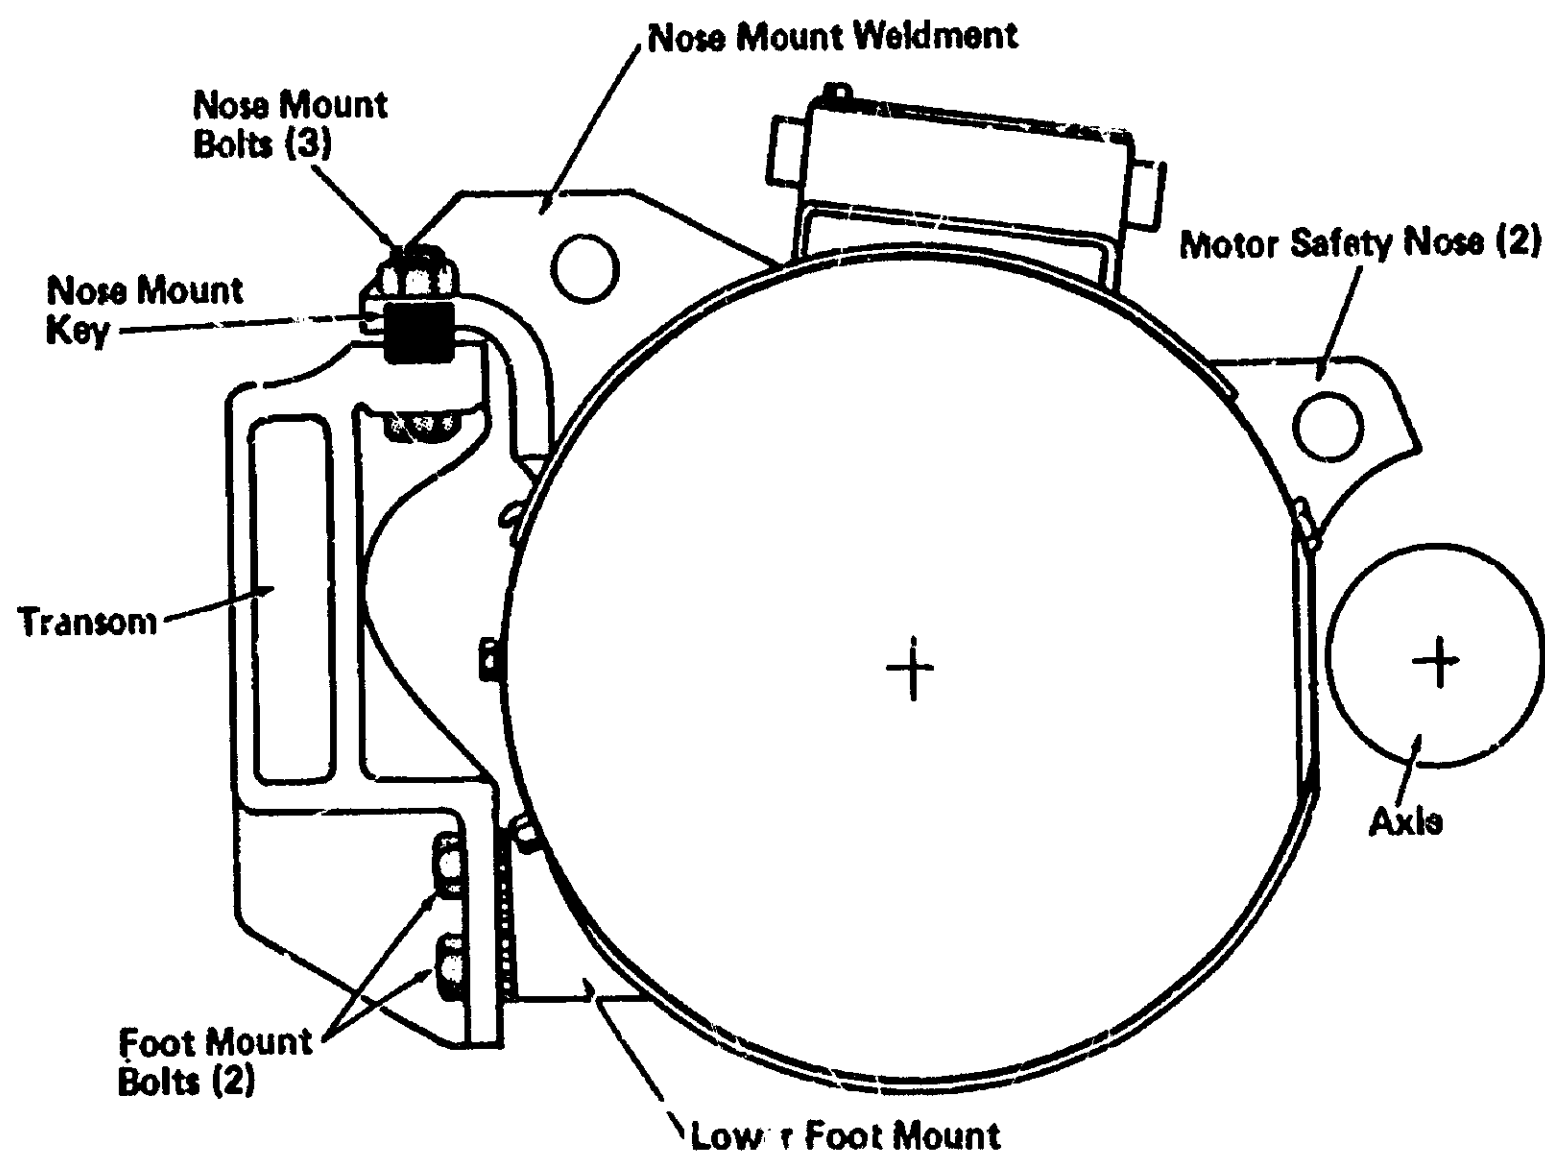
Figure 5.--Traction motor mounts on the cars involved in each derailment.

Traction Motor Mounts.--A metallurgical examination of the traction motor mounts involved in the December 15, 1981, derailment found that the lower foot mount fillet welds which attach the mount to the traction motor frame had failed. However, because the mount pounded severely against the motor frame after separation, any evidence of the failure mode in the welds was destroyed. Examination did reveal that small secondary cracks were present in the welds.

The lower foot mount bolts exhibited cracking in the thread roots, and there was evidence of fatigue. The bolts were the correct type and grade for this installation. A visual study of the threads of the bolt holes showed considerable thread wear in the first seven to eight threads, mostly fine galling and surface distortion. Examination of the fractured upper nose mount indicated a shear mode of separation.

A metallurgical examination of the traction motor mounts involved in the January 12, 1981, derailment found that the lower foot mount bolts had broken off in the holes about 1/2 inch below the surface of the mount. Both bolts had failed by reverse bending fatigue. The fatigue cracks propagated approximately halfway through the bolt before final fracture by overstress. The fracture features of the upper nose mount were typical of an overload failure. There was no evidence of fatigue or other progressive type failure in the nose mount.

The bolts from the failed lower foot mount involved in the derailment of March 7, 1982, were missing and not recovered. Examination of the bolt holes of the lower foot mount revealed that the internal threads had stripped.
